CAPE LAMBERT CONVEYOR BELT REPAIR, AUSTRALIA

SikaBond® R&B-100

CAPE LAMBERT CONVEYOR BELT REPAIR

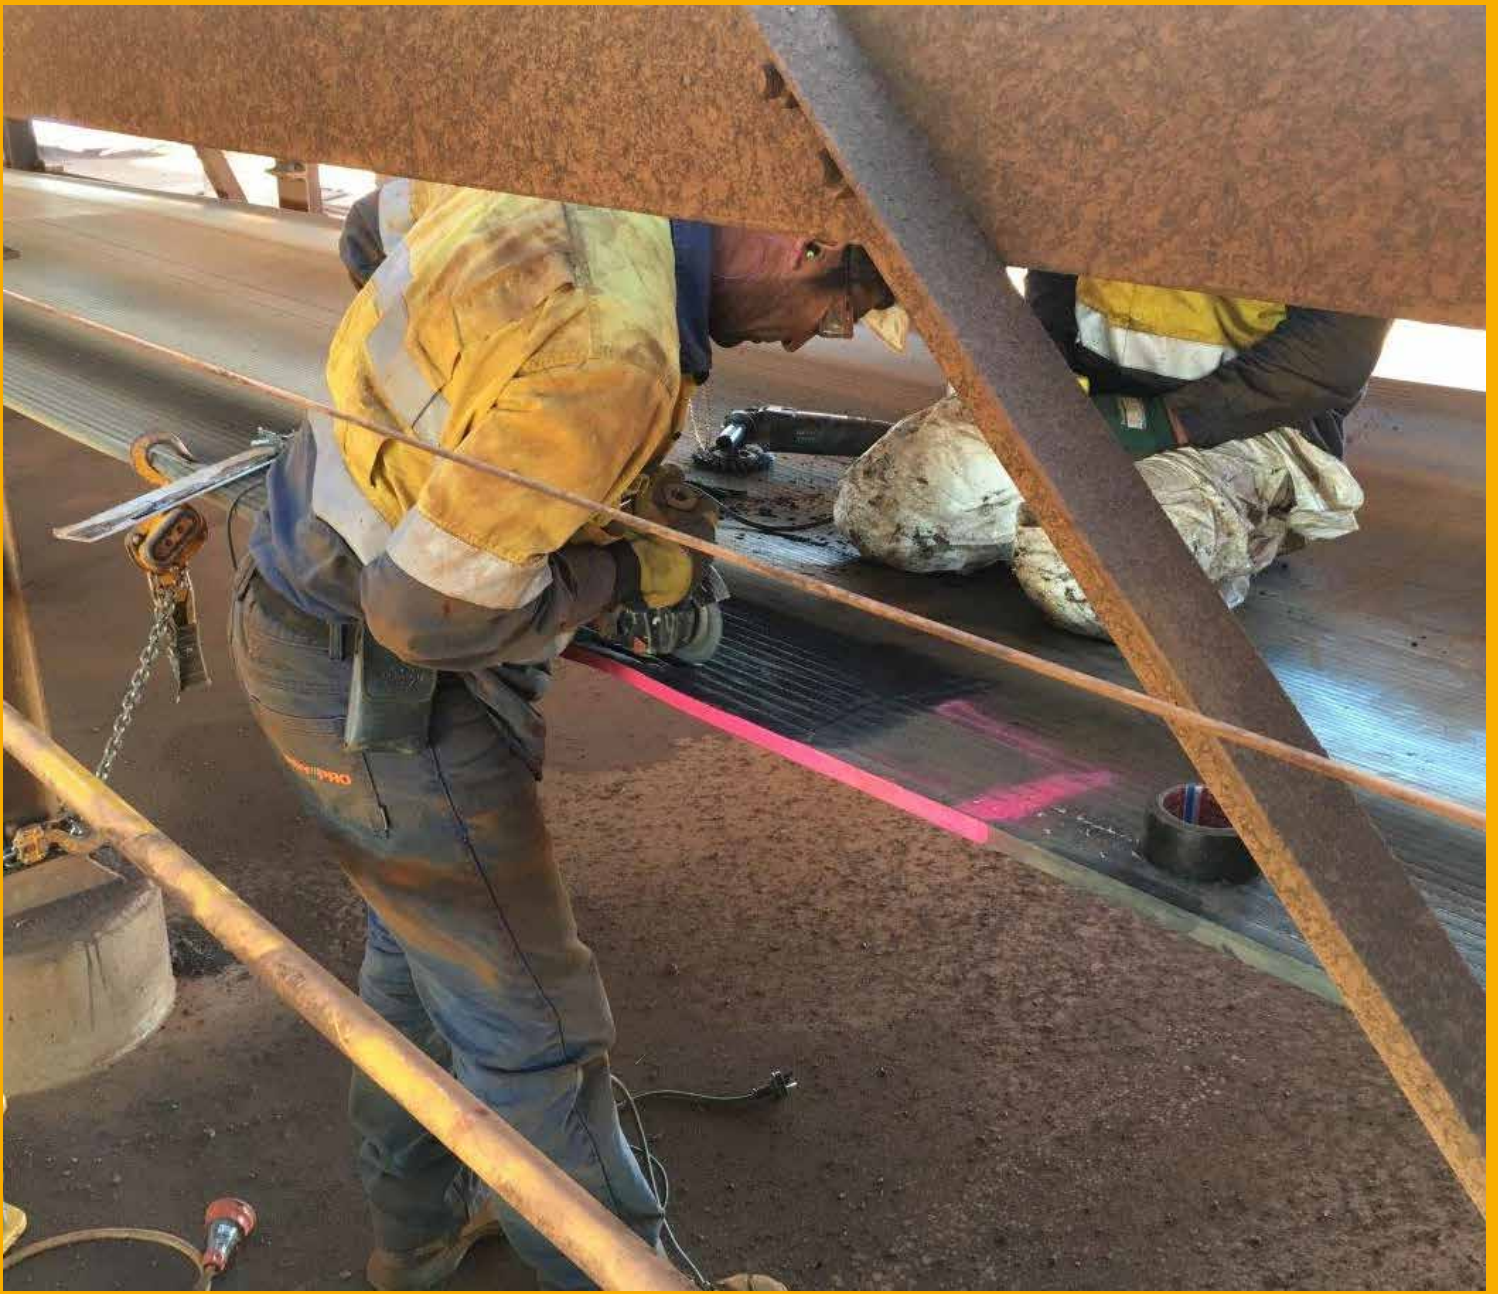
Front: Preparing the repair area of the ST belt,

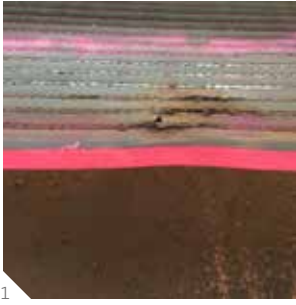
1 Damaged steel cords of the ST belt, note the exposed cords along the entire belt sections where the bottom cover is strongly reduced.
