SIKA AT WORK

CONDUCTOR REPAIR FOR GAS FIELD COMPLEX, OFFSHORE SARAWAK, MALAYSIA

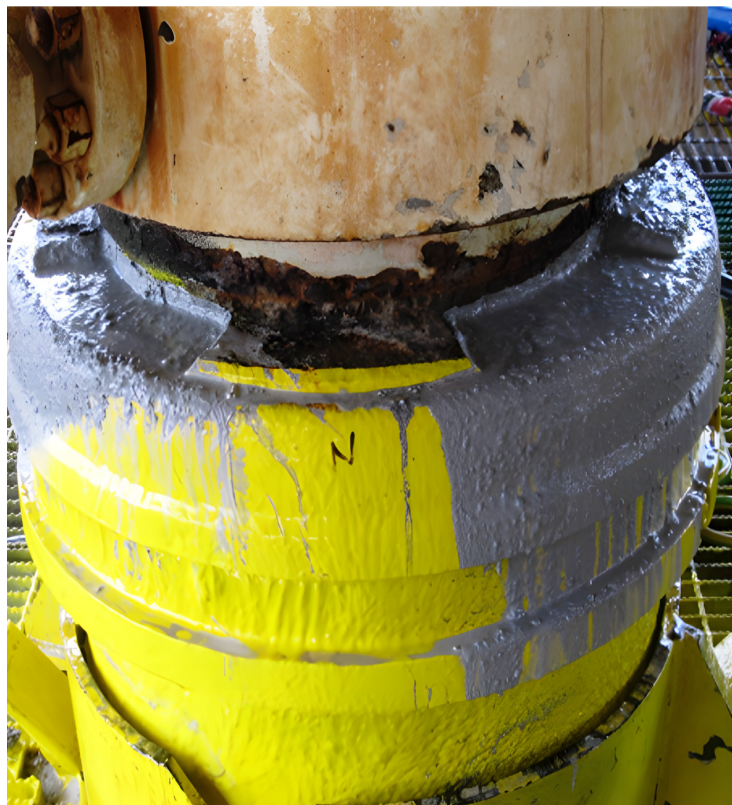
In March 2012, Sika worked in collaboration with Sarawak Shell Sdn. Bhd. to carry out structural reinstatement and corrosion repair of a conductor on an offshore platform in the Sarawak gas field. The conductor, located in the splash and tidal zones, exhibited severe corrosion that compromised its structural performance and exposed the inner casing to further degradation.

The 26-inch conductor had corroded extensively, with suspected damage also affecting the 18 5/8-inch inner casing. In this condition, well loads were being redistributed across the remaining intact casings, raising the risk of structural failure. The client required a durable, diver-free repair that could restore bending and shear capacity across the affected zone while minimizing offshore equipment footprint and avoiding hot-work operations.

Sika provided a full-service well integrity solution using Ultra-High-Performance Concrete (UHPC) grout and a custom-designed formwork system. The repair involved the installation of vertical steel rebars to restore bending resistance, with shear studs included to ensure effective shear transfer between the conductor and the repair material.

Prior to installation, marine growth was removed using ultra-high-pressure water jetting to ensure clean bonding surfaces. The prefabricated mold was then installed from the bottom of the spider deck to -4 meters below mean sea level. All work was carried out from the platform's main deck, with no divers required.

The UHPC grout was injected into the formwork to fully encapsulate the conductor and inner casing. Due to the rapid strength development of the UHPC, the formwork was safely removed just 24 hours after casting. The repair method and structural behavior were validated using Finite Element Modelling (FEM) analysis.
