# SIKA AT WORK

## MM-17 WELL CONDUCTOR REPAIR, OFFSHORE BRUNEI

# MM-17 WELL CONDUCTOR REPAIR, OFFSHORE BRUNEI

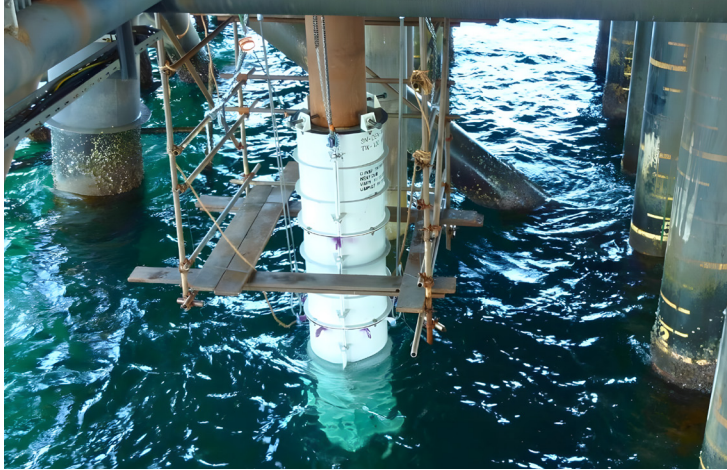
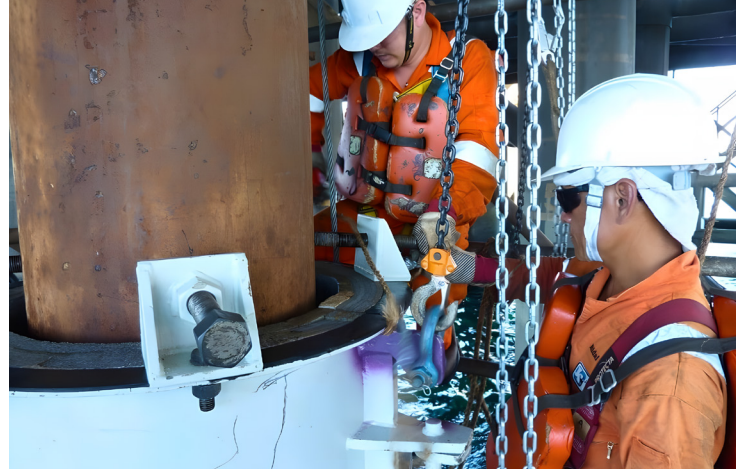
In October 2012, Brunei Shell Petroleum engaged Sika to carry out well integrity services on the MM-17 well conductor, located on the MMDP-01 platform offshore Brunei. The 24-inch conductor, located in the splash zone, exhibited external corrosion and required structural reinforcement and protection.

The conductor had experienced localized corrosion in the splash zone, raising concerns about ongoing exposure and structural capacity. A fast, diver-free repair solution was needed to encapsulate and strengthen the conductor in-situ without the need for hot work or extended downtime.

Sika supplied 3 metric tons of ultra-high-performance cementitious grout, specially selected for its rapid strength gain and excellent bonding properties in splash zone environments. A bespoke external clamp was designed by Sika's engineering team, incorporating a tailored opening and closing mechanism that allowed installation without diver support.

Scaffolding was erected from the platform to access the repair area, enabling clamp installation at approximately 2 meters below mean sea level. Prior to grouting, marine growth was removed to ensure clean bonding surfaces. The annular space between the clamp and conductor was then grouted from 2 meters below to 2 meters above MSL to fully encapsulate the corrosion zone.

The grout achieved approximately 50% of its long-term strength within 24 hours, allowing the clamp to be safely removed the next day and minimizing offshore duration.
