# SIKA AT WORK

## SAAS-FEE CAR PARK, SWITZERLAND

Repair and Protection solutions for aged parking garages P3 and P5

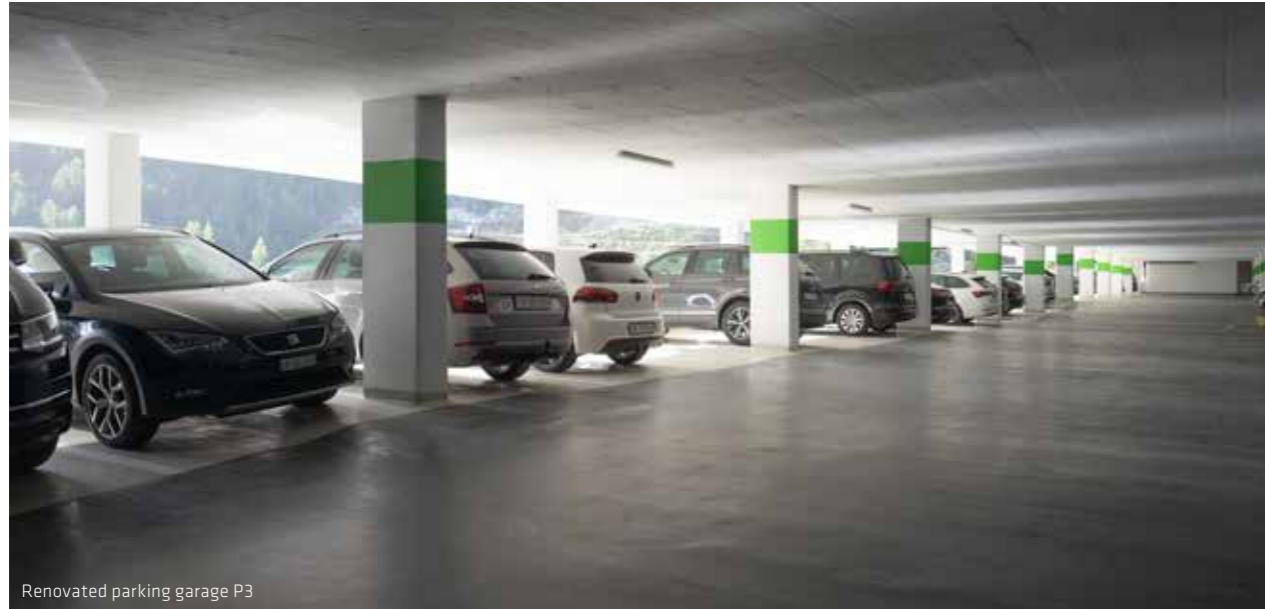
Renovated parking garage P3

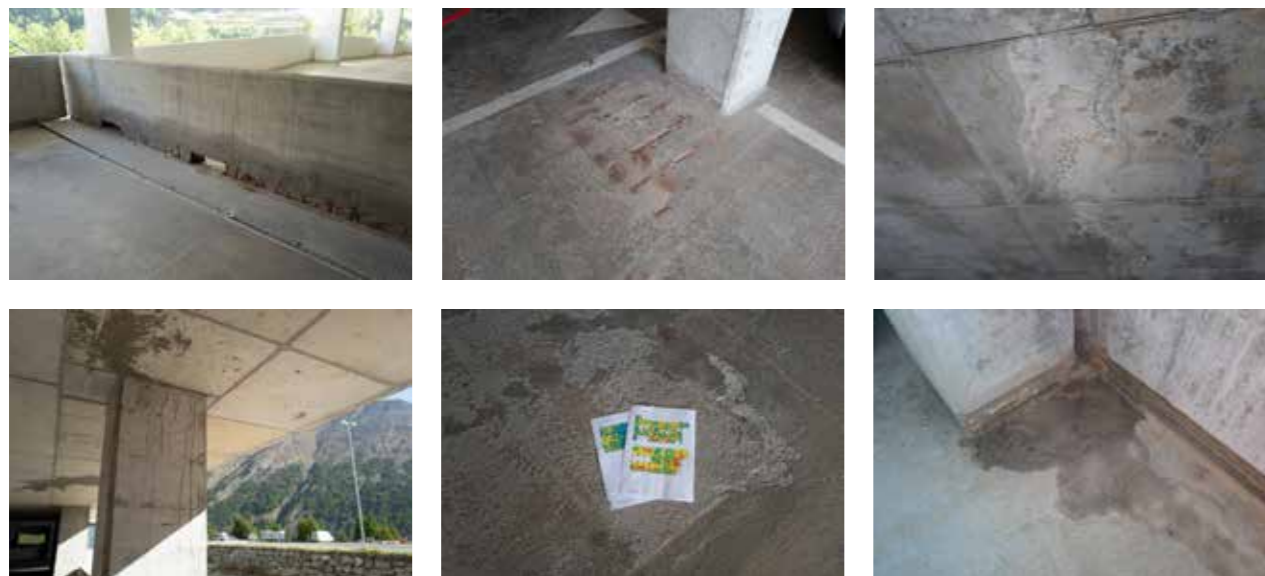
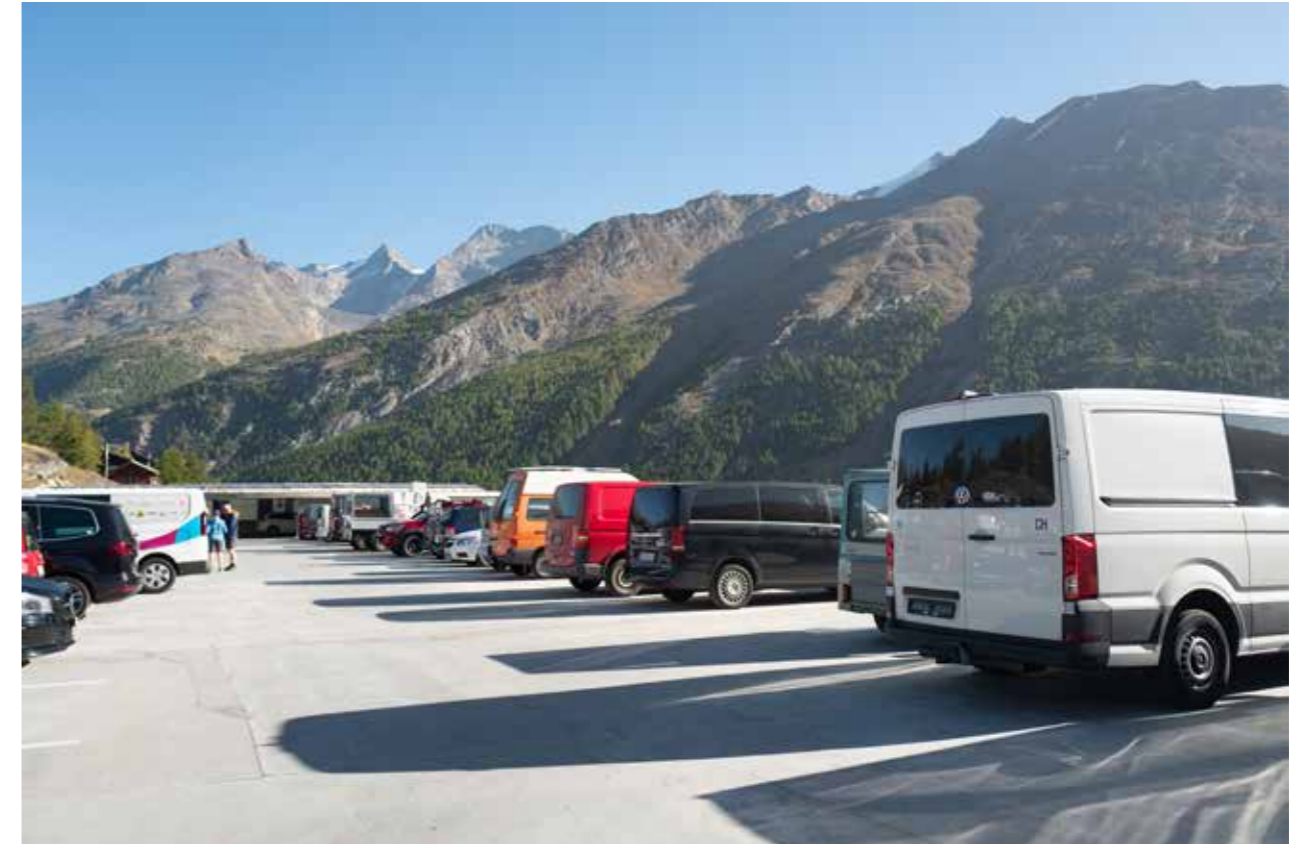
## TYPICAL DAMAGES IN SAAS FEE CAR PARK BEFORE REFURBISHMENT

Parking garage P3 (9-story) and P5 (11-story) were built in 1980s. Both of them recently showed serious age-related damages due to chloride induced corrosion and freeze and thaw cycles. In order to guarantee the safe use of the

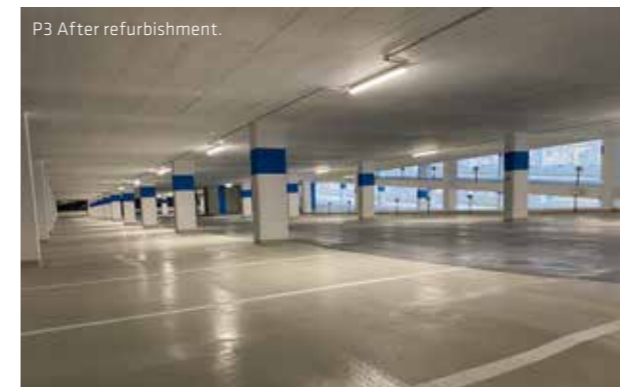
P3 After refurbishment.

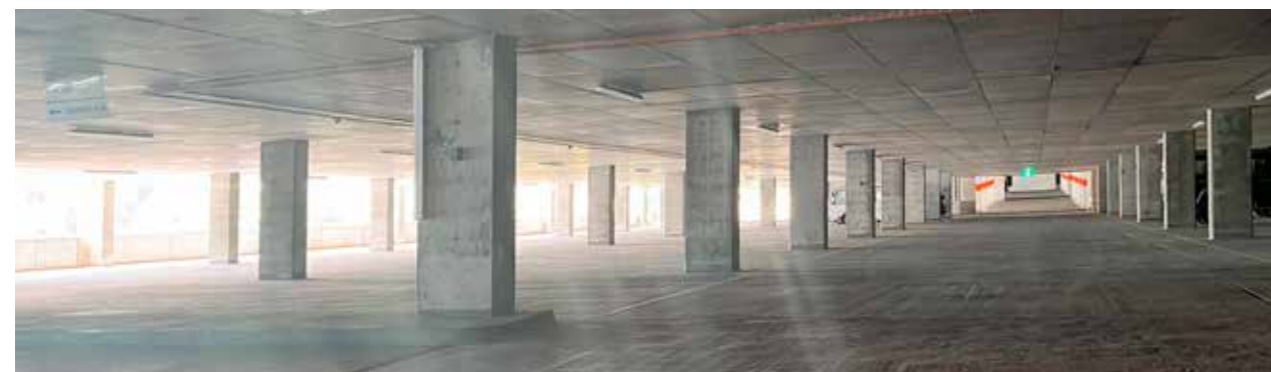
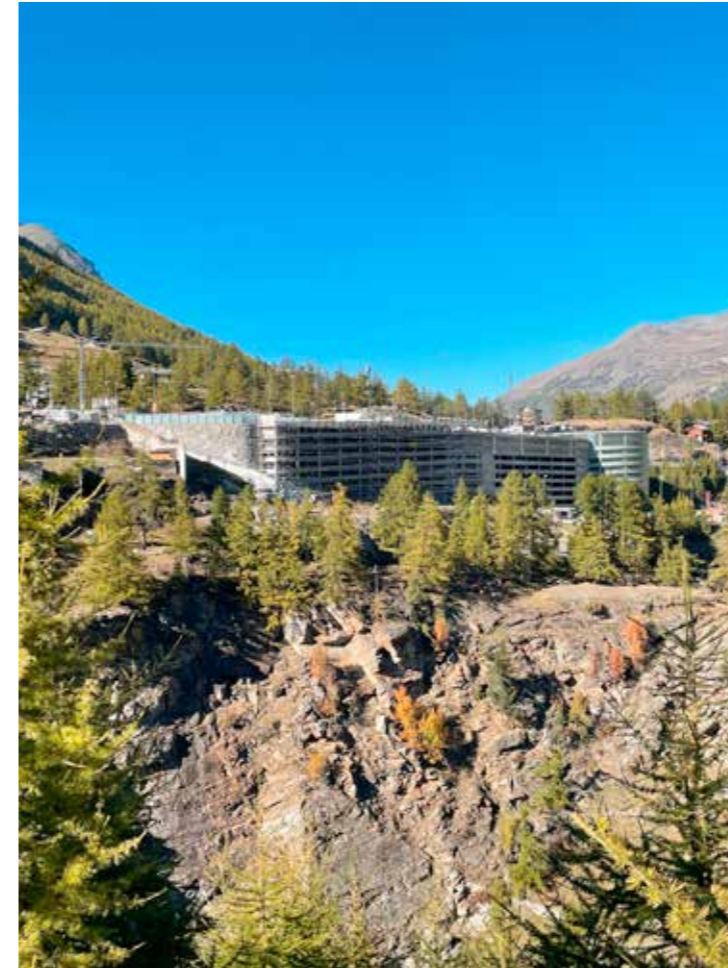
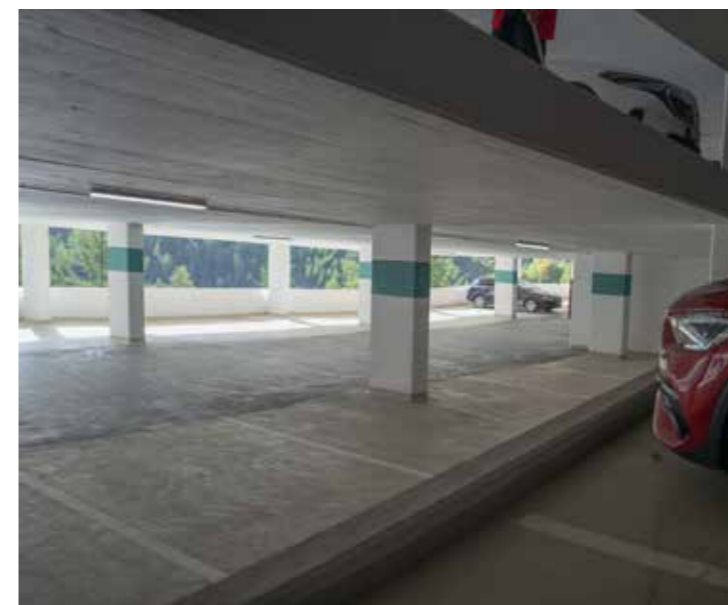
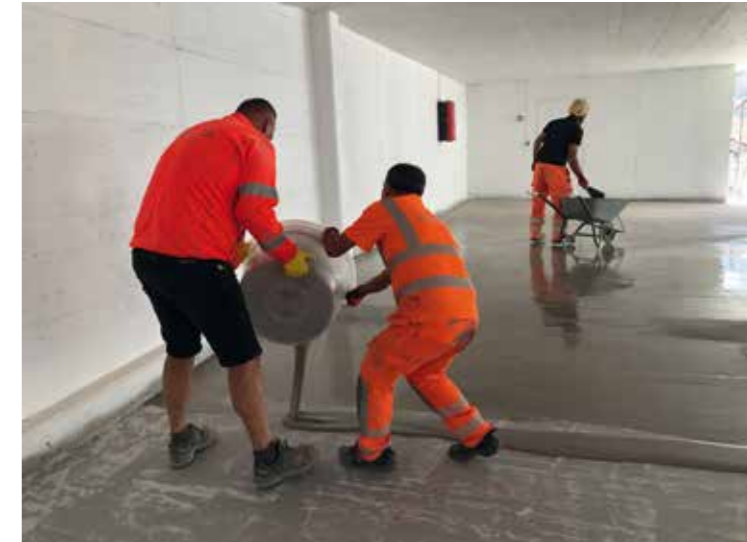
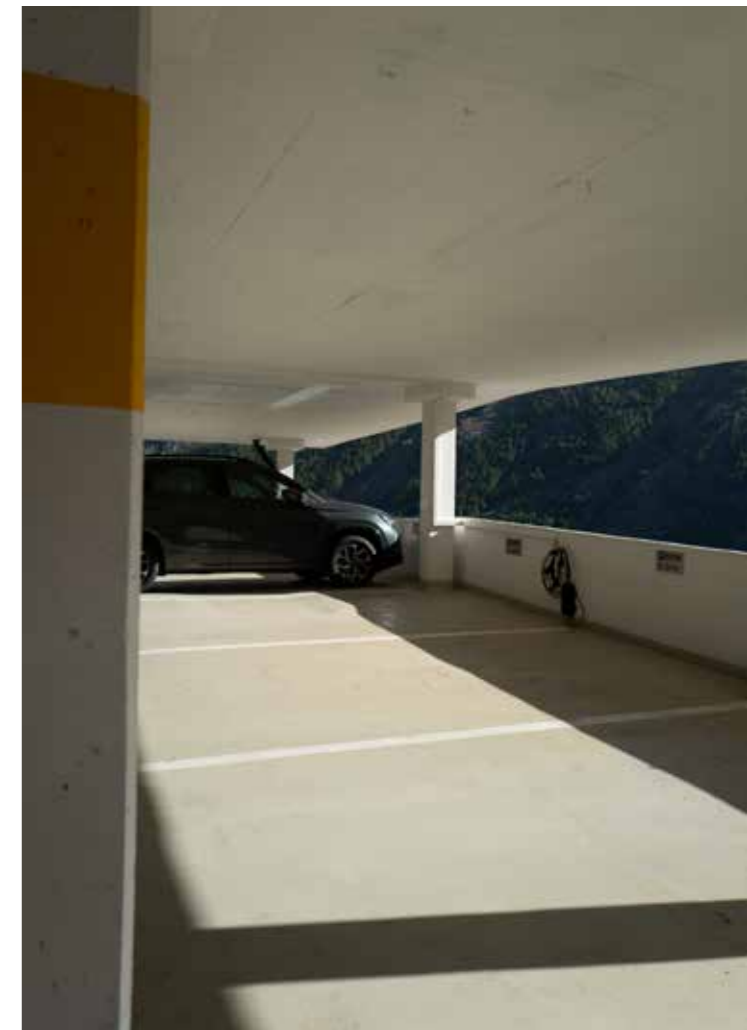
Damaged concrete floors were removed using ultra-high-pressure water. Ceilings, walls, and columns were cleaned with high-pressure water, revealing inadequately covered reinforcement.

Following the preparation, various repair and protective products were applied:

Concrete repair	
Sika MonoTop®-910 Eco	Primer for concrete with bonding slurry for subsequent mortar application on concrete.
Sika MonoTop®-412 Eco	Mortar for the reprofiling of voids, fillets, and defects in concrete.
Sika MonoTop®-452 N	Mortar for the reprofiling of irregularities in concrete surfaces.
Sika MonoTop®-422 PCC	Mortar for the reprofiling of irregularities in concrete surfaces.
Sealing	
Sikadur-Combiflex® SG System	Sealing of construction and movement joints in structural concrete.
Sikaflex®-406 Pavement	Sealing of joints in drivable surfaces.
Sikadur® Injection-52	Injection of cracks in concrete structures.
Structural strengthening	
Sika® CarboDur® S	Structural reinforcement of a concrete ceiling with CFRP (Carbon Fiber Reinforced Polymer) laminates.
Sikadur®-30	Epoxy resin-based adhesive system for CFRP laminates.
Concrete protection	
Sikagard®-675 W ElastoColor	Coating of concrete ceilings and walls.

Flooring	
Sikafloor® EpoCem Modul	Primer for subsequent self-leveling flooring.
Sikafloor®-81 EpoCem	Self-leveling flooring for leveling the unevenness in the parking decks.
Sikafloor®-161	Epoxy resin-based primer for subsequent synthetic resin floor coverings.
Sikafloor®-390 N	Coating of the parking deck floors.
Concrete Floor Repair	
SikaScreed®-30 CBB	Primer for the subsequent hard concrete topping on the top (uncovered) parking deck.
Hard concrete surface	UHPC (Ultra High-Performance Concrete) for ramps and parking decks.

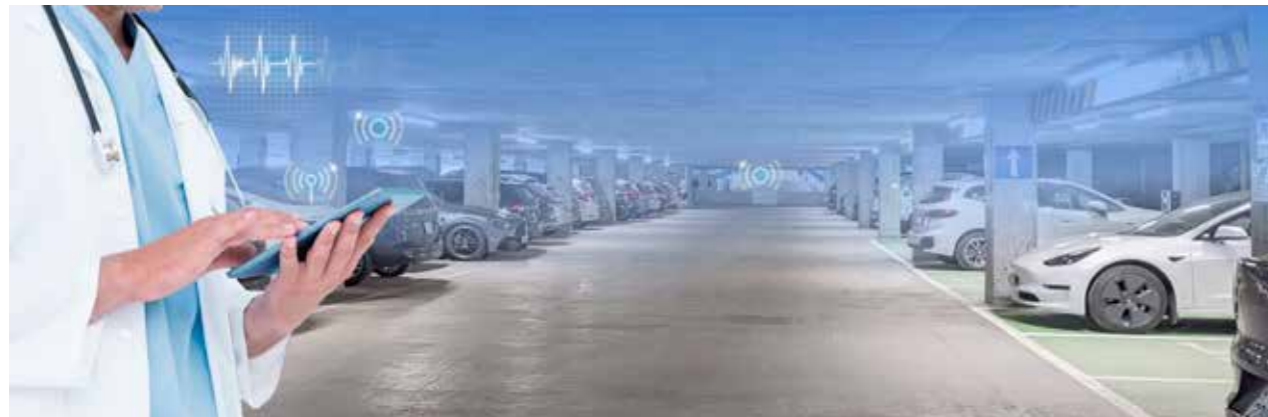
# DURAMON'S STRUCTURAL HEALTH CORROSION MONITORING SYSTEM AT P5

The P5 car park in Saas Fee is an eleven-story structure. During an inspection in 2022, extremely high chloride contents were discovered in many areas, exceeding the limit of 0.4% by mass based on cement as specified in SIA standard 269/2.

Despite the elevated chloride content, corrosion had not yet initiated or had not reached a critical level. This could be attributed to the relatively dry conditions of the concrete, which inhibited corrosion propagation. However, the presence of such high chloride levels poses a significant risk of corrosion, which could potentially jeopardize structural safety if moisture enters the concrete.

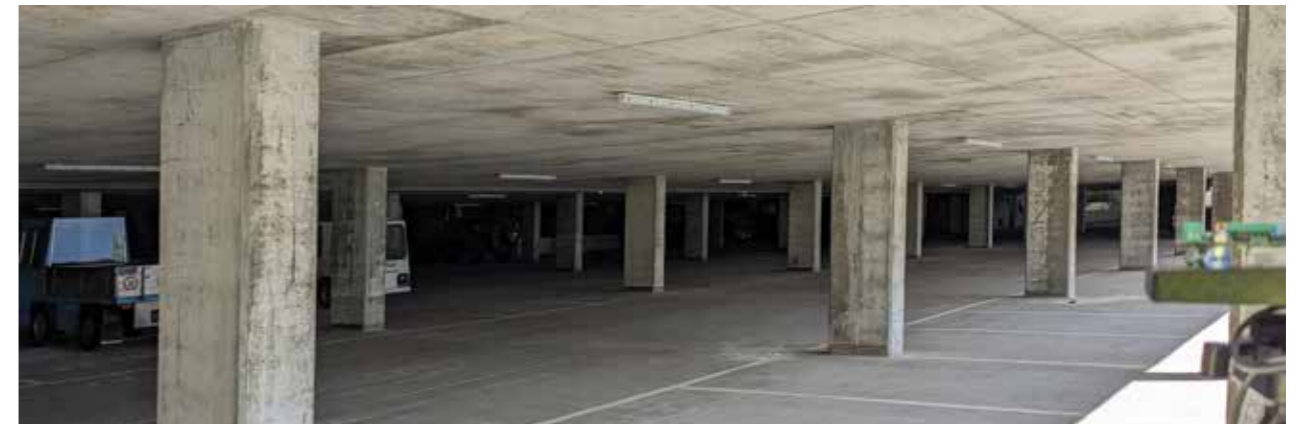
DuraMon multisensory were installed in well defined locations in the existing concrete structures. Some of these locations were protected with Sikagard® or Sikafloor® coatings, while the rest remain untreated (reference areas). The following photos show the installation on the construction site.

DuraMon's structural health corrosion monitoring system was installed between September and October 2023. This system monitors the condition of the structure over time, both in areas with Sika's protective system (Sikagard® and Sikafloor®) and in areas without any protective system (reference areas).
