# SIKA AT WORK WELL INTEGRITY SERVICES, BSP 2015 CAMPAIGN, BRUNEI

## WELL INTEGRITY SERVICES, BSP 2015 CAMPAIGN, BRUNEI

Project name: Well Integrity Services, BSP 2015 Campaign

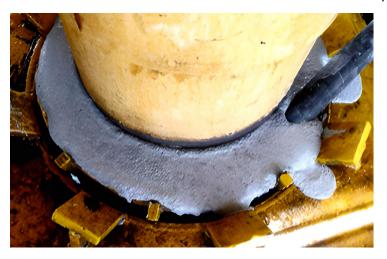
Well inspections revealed widespread corrosion between the surface casing and conductor on multiple wells. To maintain well integrity and avoid production losses, the client required a cost-effective, long-term repair solution that could be executed without interrupting operations or requiring hot work permits.

Sika supplied ultra-high-performance cementitious (UHPC) materials and provided offshore cleaning and grouting services supported by a compact, zone 2 rated equipment spread. Prior to grouting, the existing deteriorated cement was removed using a 3-in-1 cleaning system combining a hydraulic jack hammer, high-pressure water jet, and selfcontained power supply.

The annular space between the surface casing and the conductor was then grouted with UHPC to stop oxygen ingress and restore structural continuity. The material's excellent bonding properties created a dense, impermeable seal that halted the corrosion process and reinforced the conductor assembly.
