SIKA AT WORK BALAM TA2, GROUTED JACKET INSTALLATION, MEXICO

BALAM TA2, GROUTED JACKET INSTALLATION, MEXICO

Project name: Balam TA2 Grouted Jacket Installation Balam Field, Gulf of México 2022 lacket installation SikaGrout®-9610

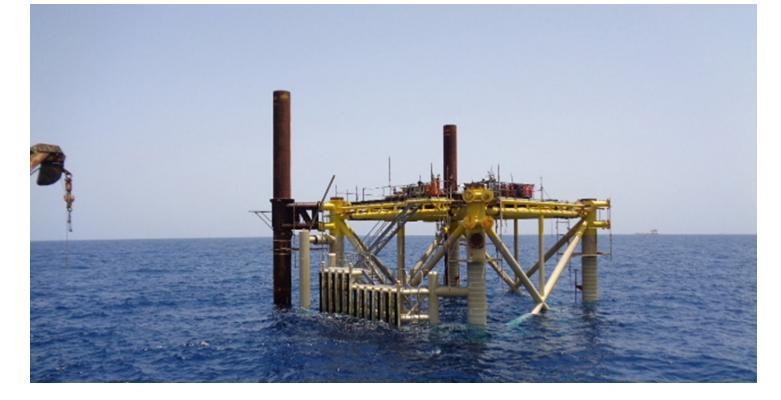
Sika was engaged by Permaducto S.A. de C.V. to support the installation of the Balam TA2 platform, a four-legged jacket structure located in the Balam Field in the Gulf of Mexico. Using Sika's proprietary SikaGrout®-9610 High-Performance Cementitious (HPC) grout, the team successfully secured the platform to the seabed at a depth of 55 meters through precise pile-sleeve grouting, ensuring the platform's stability and long-term reliability.

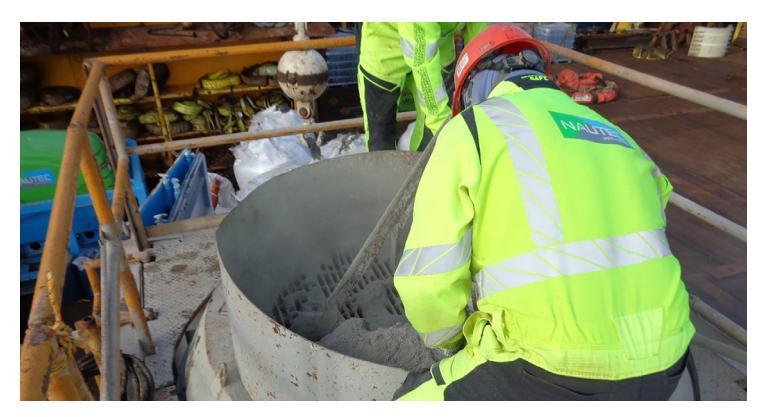
Sika supplied SikaGrout®-9610 HPC grout and developed a custom grouting procedure for the Balam TA2 platform installation. This fourlegged pile-sleeve structure with four skirt piles required 22m³ (44 tons) of grout, but 52 tons were used to ensure a strong, reliable installation. Sika provided the offshore crew as well as compressive strength testing results in a final closeout report, meeting the client's requirements.

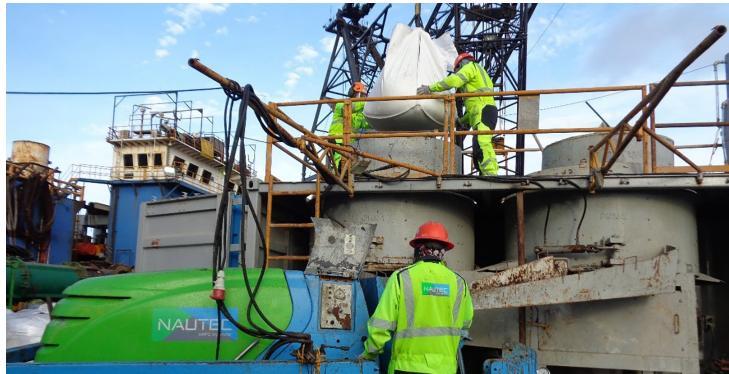
The Balam TA2 installation required a comprehensive grouting procedure, project documentation, and specialized equipment, including grout material, offshore mixing and pumping systems, grout hoses with 40% contingencies, and quick-connect inlets and outlets for smooth operations. Additionally, a skilled offshore crew was essential, comprising a grouting supervisor, engineer, certified QC technicians, and rigging specialists with the necessary equipment.

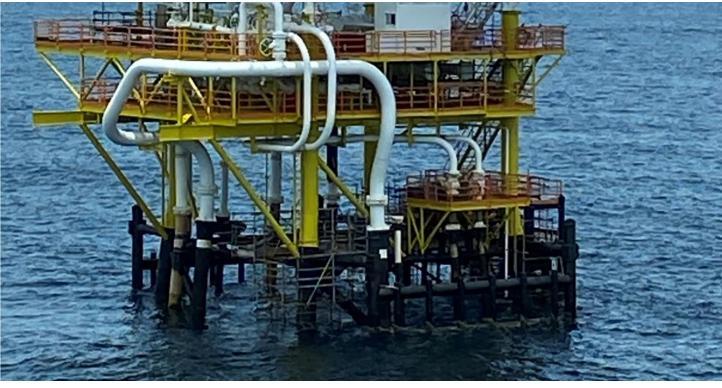
During the offshore operations, the team encountered issues with failing grout seals at the bottom of the annulus. This would have delayed the project, but the team devised an innovative workaround by using a range of aggregates to temporarily block the annulus at the seal level. This solution allowed the grouting to proceed successfully, ensuring the job was completed without any operational downtime.
