SIKA BRIDGE REPAIRS - KEEPING ATLANTA MOVING

Sika recently helped to complete vital repair works on a collapsed interstate bridge in Atlanta, Georgia. The team worked with Thomas Concrete and a new product - Sika® Control NS – to complete the work in just six weeks, a full month ahead of Georgia Transportation Department's tight timescale.

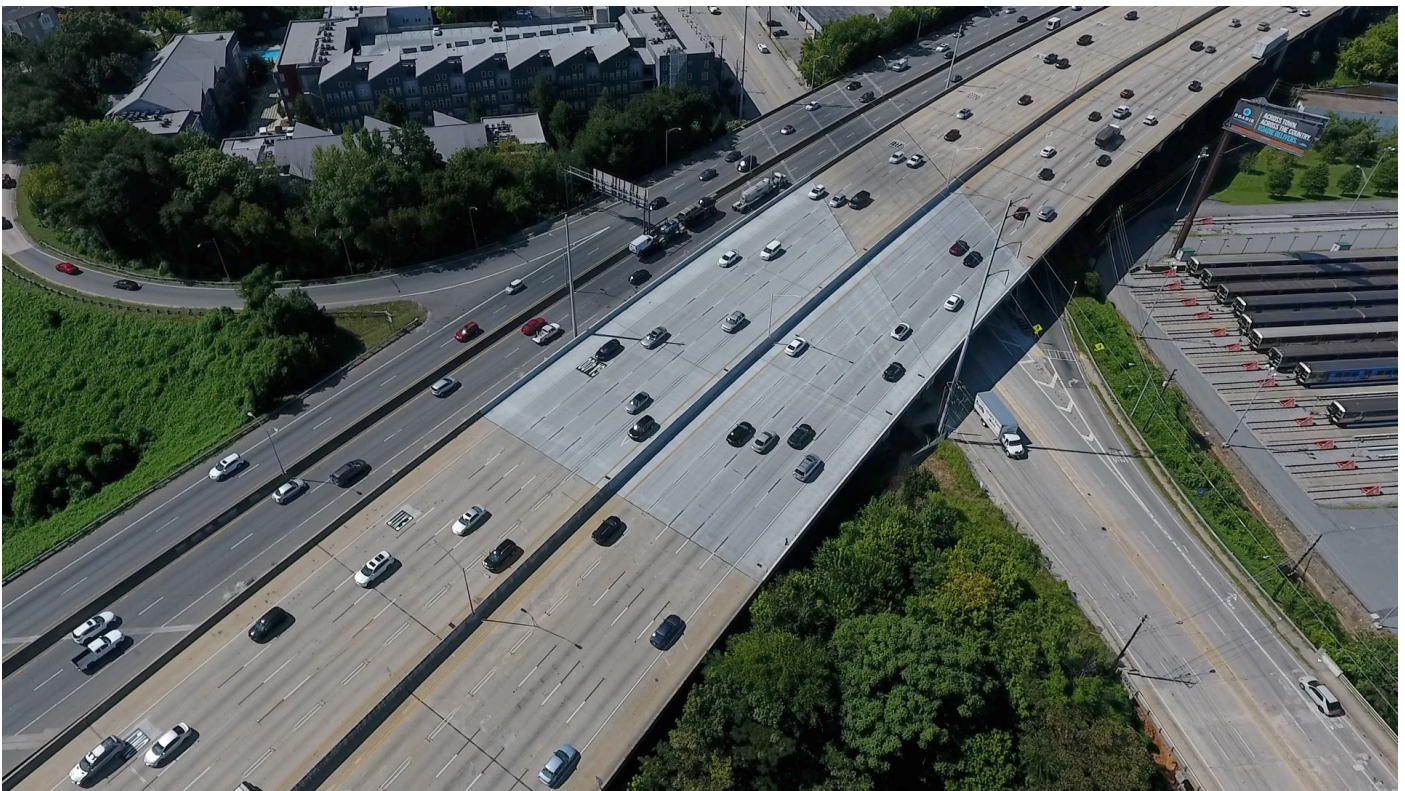
The collapsed bridge of highway I85 in Atlanta, Georgia, was repaired and reopened for traffic in just six weeks.

Sika® ViscoCrete®-2100, one of Sika's leading concrete admixtures, and Sika's new product Sika® Control NS were both supplied to support the repair project. Sika® ViscoCrete®-2100 was used to achieve design strength of the structure in less than seven days without the use of accelerators, whilst Sika® Control NS – a shrinkage compensating admixture - was used for the bridge deck to provide a crack-free and durable surface.

As a result of excellent teamwork, the repair was completed in just six weeks, a full month ahead of schedule. This also meant tremendous cost savings considering the estimated USD 850,000 for each additional day that the closed bridge would have cost.

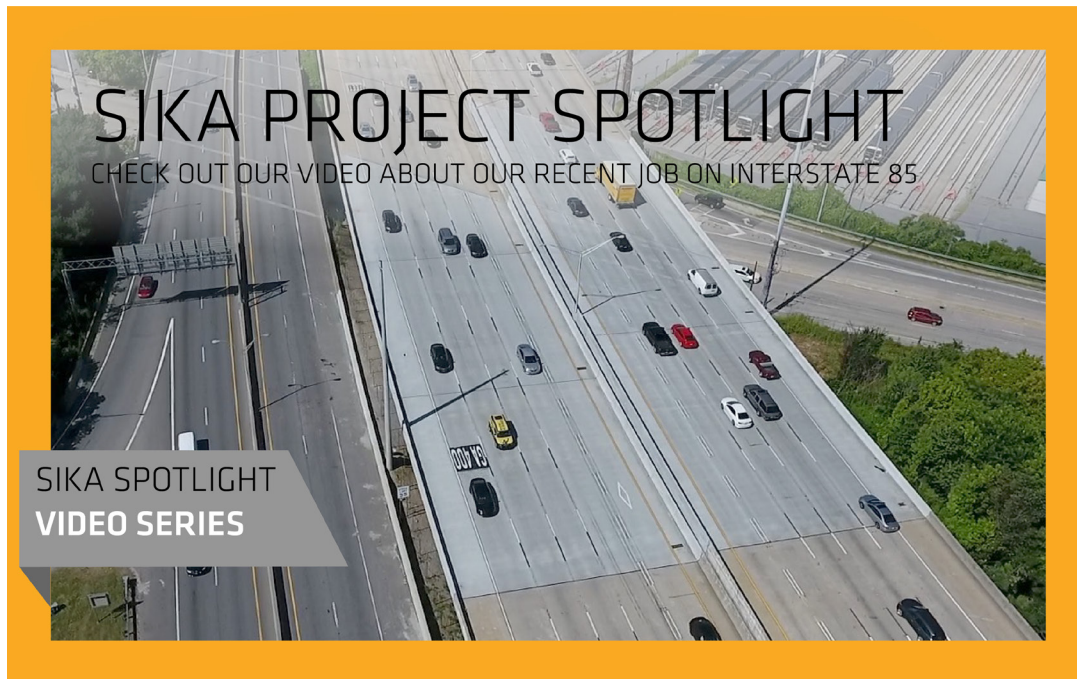
Thomas Concrete worked fast to cast new columns and a bridge deck. Justin Lazenby, Technical Services Manager, commented, "It was a really fast paced project. We had to do a lot of things really quickly and the performance of Sika® Control NS and Sika® ViscoCrete®-2100 had to match our service."
