# SIKA AT WORK

## LINING OF RESERVOIR FOR SPRING WATER, TESALIA BOTTLING PLANT, GUAYAQUIL, ECUADOR

WATERPROOFING: Sikaplan® WT 4220-15 C SHEET WATERPROOFING MEMBRANE

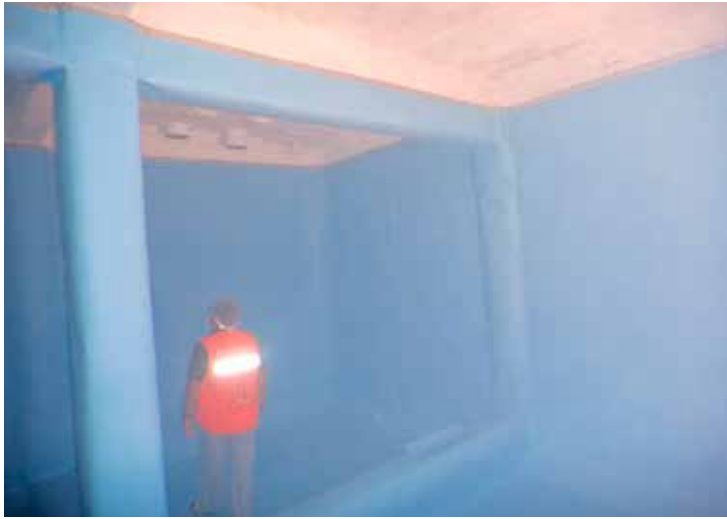
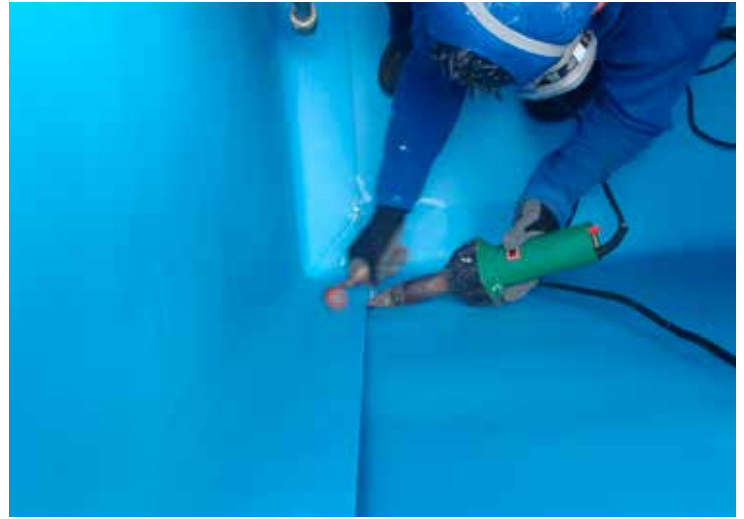
Over time there had been some deterioration of the concrete structures in certain areas, including surface erosion and issues with cracks and joint movement, leaking. Now the owners and their professional advisors wanted to find a durable solution to maintain the unique character and quality of the Spring water and to ensure that there were no problems in the future due to loss of water, or to the ingress of contaminants that could lead to poor water quality.

After emptying the tanks, the concrete surfaces were cleaned by high pressure water jetting, which was also used to remove any damaged or deteriorated areas, all of the surfaces were then disinfected using Sika® Cleaner, to eliminate any residual micro-organisms.

The Sika® Waterstopping Mortar was used to seal any visible infiltrations, followed by reapplication of the Sika® Cleaner again locally when all water ingress was halted. SikaTop® Repair and Levelling Mortar was then used where necessary to restore the original concrete surface and profile where required.

Finally the internal waterproof lining was installed using a special Sika-plan® WT sheet membrane system, which consists of flexible polyolefin-based membranes, reinforced with a glass fibre fabric. Additionally, Sikaflex® adhesive sealant was used to fix and seal around the flexible membranes for detailing required due to the complex surface geometry in the upper area of the reservoirs.
