# SIKA AT WORK SERVICE RESERVOIR, KENT, UNITED KINGDOM

WATERPROOFING: Sikalastic®, SikaTop®, SikaLatex®

### PROTECTION OF STEEL COLUMNS AND WATERPROOFING OF CONCRETE WALLS

$\textbf{Project name:} \ \mathsf{Service} \ \mathsf{Reservoir.} \ \mathsf{Protection} \ \mathsf{of} \ \mathsf{steel} \ \mathsf{columns}$

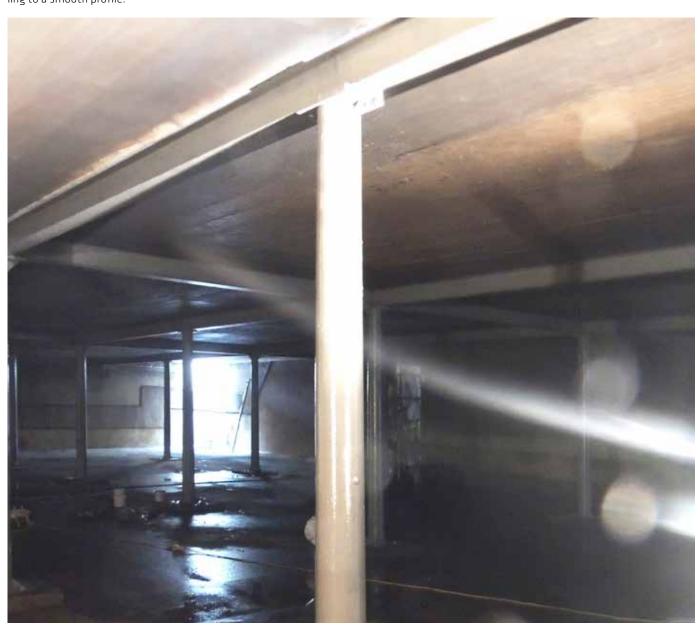
The concrete surface was treated with high-pressure water to remove all contaminants. The steel columns were grit-blasted to eliminate corrosion products, after which Sikalastic® M 808 was applied in two coats using roller and brush. With a rapid return-to-service time of seven days at 7°C, Sikalastic® M 808 enabled the reservoir to be recommissioned on schedule.

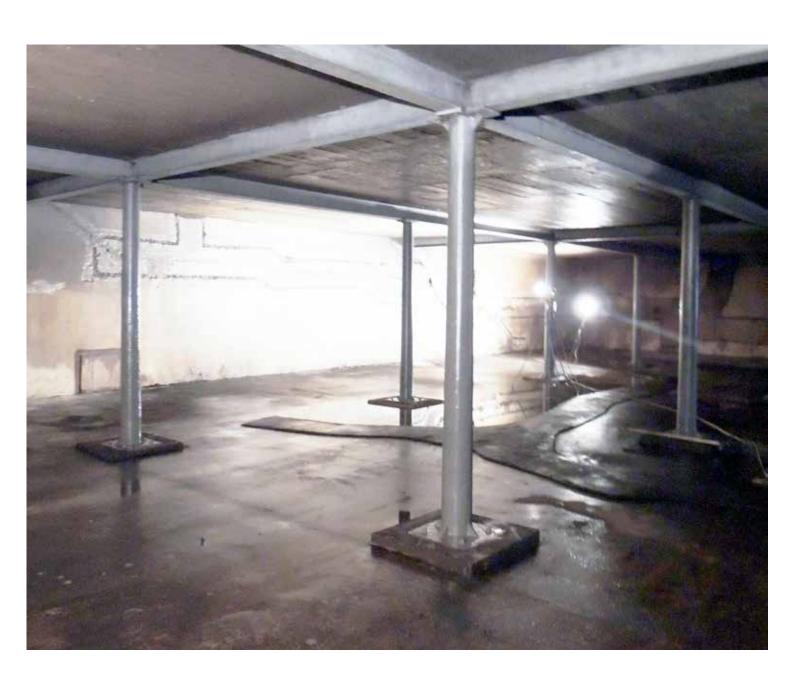
SikaTop® 586 Seal, mixed with a SikaLatex®-600/water blend, was applied in a single 3 mm layer to create a smooth surface, re-profile the original concrete wall finish, and protect from the effects of the water. Its rapid return-to-service time of three days at 3°C ensured there was no delay between completing the re-profiling works and recommissioning the reservoir.
