SERVICE RESERVOIR ACCESS COVERS, EAST SUSSEX, UNITED KINGDOM

WATERPROOFING: Sikalastic®, SikaTop®, Sikagard®

PROTECTION OF SERVICE RESERVOIR ACCESS COVERS

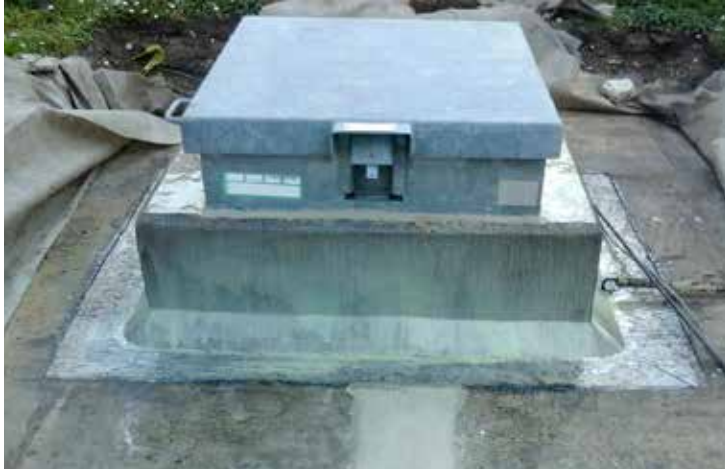
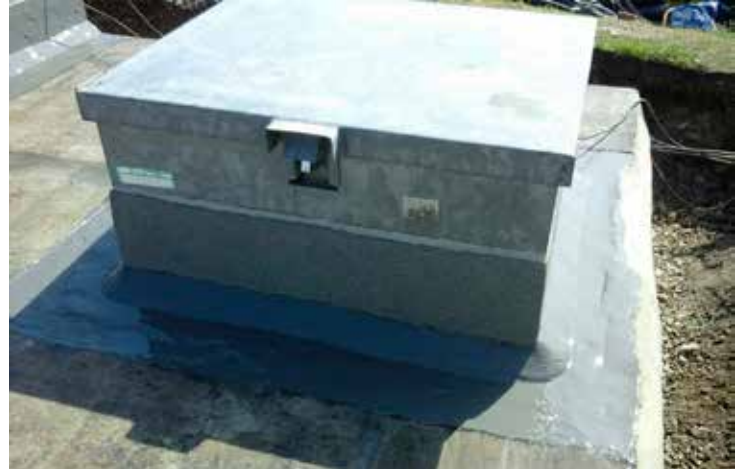
The concrete surface was ground to remove all contaminants. A fillet of SikaTop® 586 Seal levelling mortar was then applied at the base of the upstands.

Sikagard® P 770 primer was applied by roller to a damp but surface-dry concrete surface. After 24 hours, two coats of Sikalastic® M 686 were applied by roller. Sikalastic® M 686 achieved the required resistance to rain showers within 3 hours of application.

Grit was applied onto the wet Sikalastic® M 686 on the upstands to provide additional protection prior to backfilling and landscaping.
